**PRODUCTIVE LAND USE SYSTEMS**  
**Haiti**

**Technical Assessment of the Irrigation Systems of Marigot  
and Jacmel and Preliminary Observations  
on the Marigot Watershed**

**Kyung H Yoo and Dennis A Shannon**

**SECID/Auburn PLUS Report No 47  
USAID/Haiti Agriculture and Economic Growth Office**

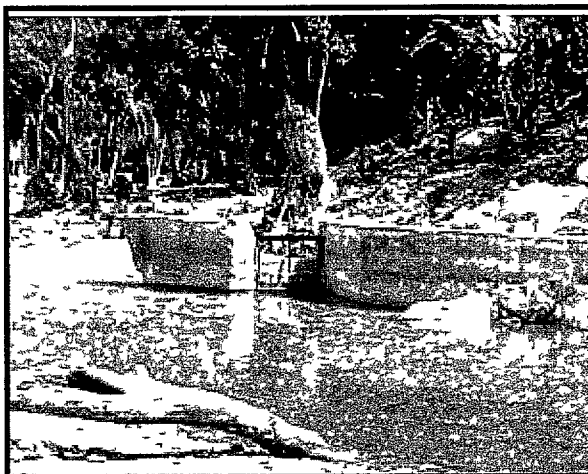
Both irrigation systems have severely damaged intake structures (*photos 1 and 2*) and conveyance structures on the intake side (*photos 3 and 4*). Based on observation of the Rodaille irrigation area, the irrigation field and most portion of the main canal and two secondary canals (*photos 5 and 6*) were not damaged as severely as the upper section of the main canal and the intake structure. However, most of the main canal section was badly sedimented at the time of visitation (*photos 7 and 8*). The sediment should have been carried and deposited by the flood from Hurricane George and/or sediment-carrying irrigation water during the normal operation. If the latter is the case, the irrigation system lacks scheduled maintenance of canal cleaning. Due to time constraints and logistics we did not visit the command area of the Belle Roche site. But we found that the intake structure and upper section of this irrigation system were severely damaged (*photos 9 and 10*). Each site will be described in terms of the damage and recommendations for renovation. The consultants were told that a local contractor has been selected for planning and designing of the water intake structure and the irrigation conveyance system renovation for both sites. Since the contractor is in the design stage of the system, our recommendations may be used to verify or confirm their plans.

**Photo 1** Inlet structure at Rodaille site Note the broken and washed out left wing and rock-anchored right wing Main canal is located behind the sluice gate

**a Severely damaged intake structure** - A new intake structure should be located on the east bank (*photo 11*) to avoid a stream crossing structure such as a siphon or flume. An upstream site from the current intake should be chosen to achieve this relocation. This observation agrees with the current plan by a local contractor which was mentioned to the consultants. However this will require a new upper section of main canal to connect to the existing main canal section that survived the hurricane.

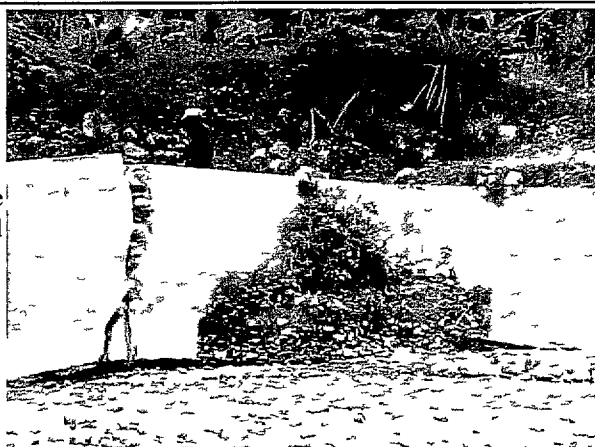
**Photo 2** Intake structure at Belle Roche site Note the broken left wing The intake sluice gate locates behind the wall covered with grass

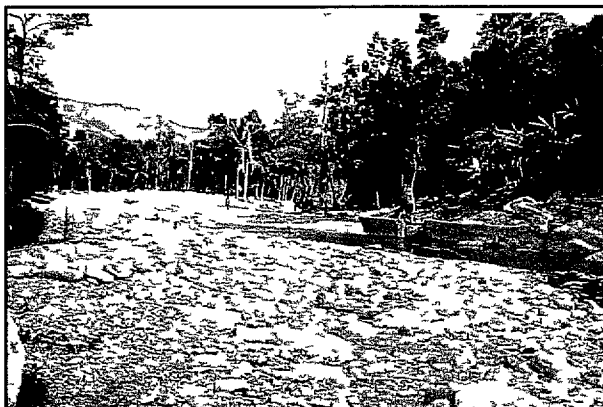
**Photo 3** Damaged upper section of main canal at Rodaille site The embankment on the left of the intake structure was broken and washed out and the river bottom was exposed to the main canal

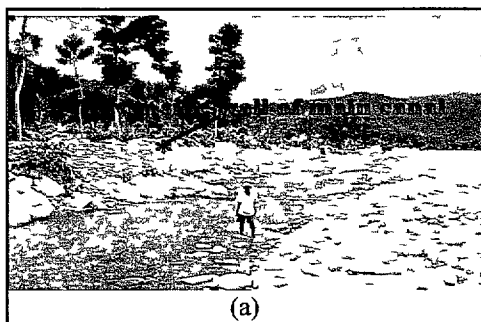
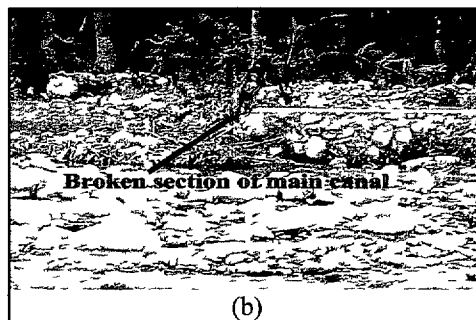
**Photo 4** Upper section of main canal at Belle Roche below the intake structure has survived due to the rock wall structured, but the lower part of this section has been broken as shown in (b)

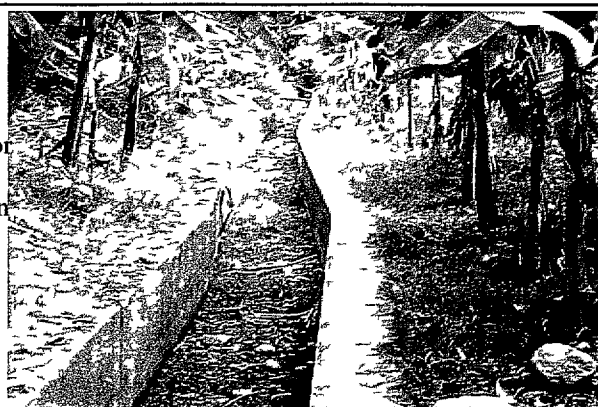
**Photo 6** Undamaged section of main canal Except for the upstream section the main canal below the siphon structure survived the hurricane George Sedimentation and trash accumulation were excessive which would cause serious problems if not adequately cleaned up

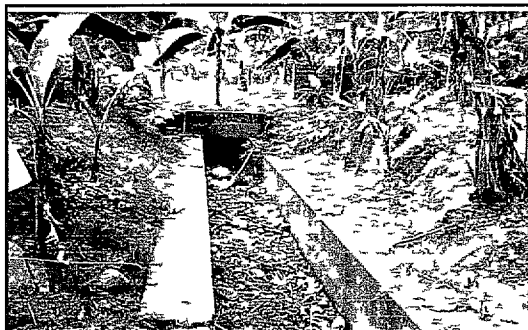
**Photo 7** Sediments and trash accumulated in a section of main canal. This is outlet side of the siphon. The canal structure is near perfect at this and most sections of the main canal. Most damage was done to the intake and siphon sections.

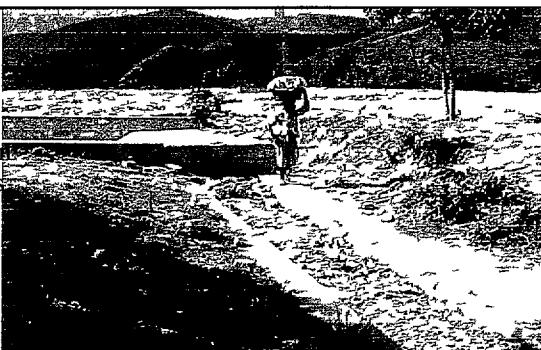
**Photo 9** Damaged intake structure at the Belle Roche site. Damaged left wing and washed foundation of the structure.

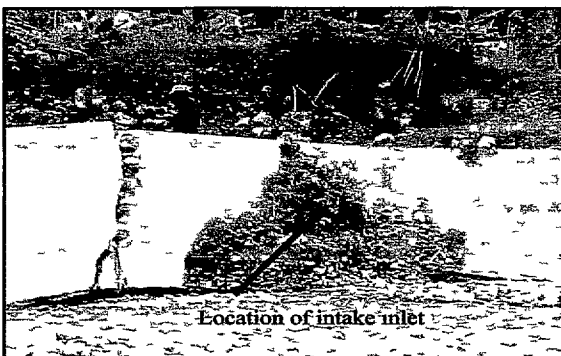
**Photo 10** Damaged upper section of main canal at the Belle Roche site. The rock-walled section of the main canal survived the flooding but the left end of the section was completely cut off.

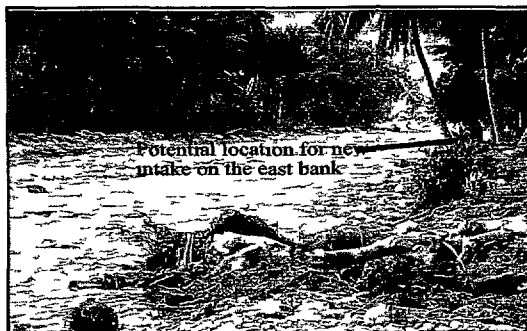
**Photo 11** Potential location of a new intake site on the east bank of the river to avoid a river crossing structure. Location is determined by the elevation change in the river which should be high enough for gravity supply to the undamaged section of the main canal. The new connecting section may be routed near the foothill to avoid future damage by flooding or bank erosion.

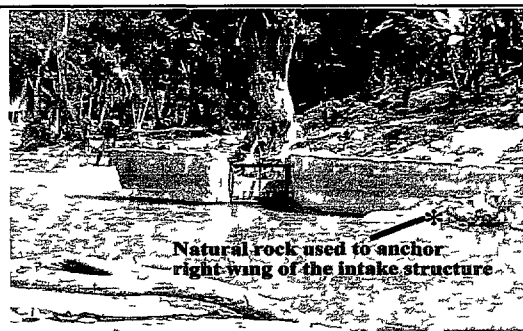
**Photo 12** Intake structure at the Rodaille site. Note that the natural rock on the right wing which was used to anchor the structure. The right wing survived the flooding due to the anchor. It is a good idea to anchor an intake structure to a strong object such as natural rock. In case no such object is found, an artificial structure similar to natural rock may be located at more convenient and proper location for intake structure. Existence of such anchoring object should not govern the

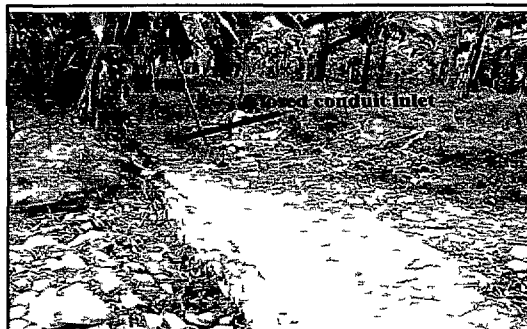
**c A sediment-filled box-type closed conduit crossing the dry bed river** - It appeared that the long closed conduit has no other damage than sedimentation in it (*photos 13 and 14*). This was observed from its inlet and outlet and manholes along the conduit. Some manholes have a raised access but at least one of them has an access lower than the ground level where foreign materials could easily enter. The main canal section between the outlet of siphon and the closed

**Photo 13** Practically undamaged closed conduit structure crossing dry-bed river. The conduit may have been filled with sediment from the flooding.

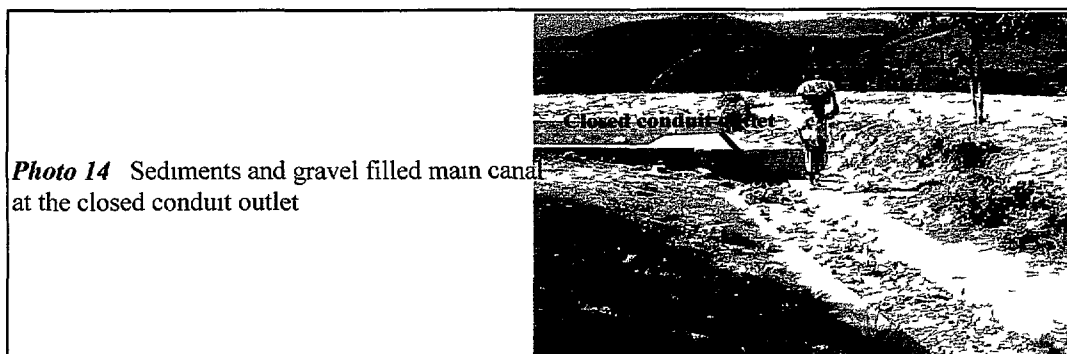
**Photo 14** Sediments and gravel filled main canal at the closed conduit outlet.

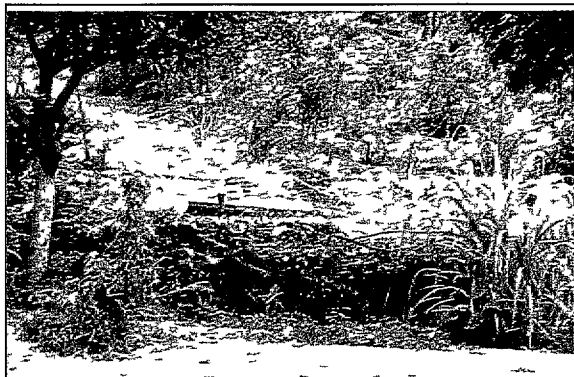
conduit was completely sedimented from the flood water (*photo 15*) Except for the sediments deposited in the upper section of the main canal, the rest of the conveyance system does not show any serious damages *It is suggested to save the upper section of the main canal below the siphon outlet and whole length of the closed conduit This would be done by re-routing the main canal from the new intake structure at or below the outlet of the existing siphon if feasible (photo 16) However, it will require certain conservation practices along the eroded east bank (photos 17) in order to stabilize the main canal below the siphon outlet and other infrastructure from flooding* Otherwise it is recommended to re-route this section of the main canal further inland near the foothill and connect to a more stable section of the main canal and to the closed conduit Such structures as siphon, closed conduit and flume are the most expensive structures per length to build for an irrigation conveyance system

**Photo 15** Main canal section between siphon outlet and closed conduit inlet

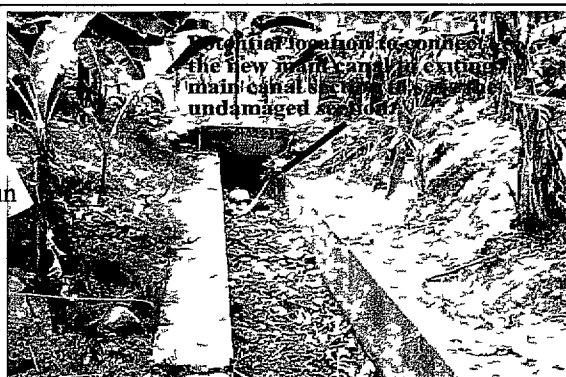
**Photo 16** Potential site to connect the new main canal to exiting main canal to save the existing main canal and the closed conduit

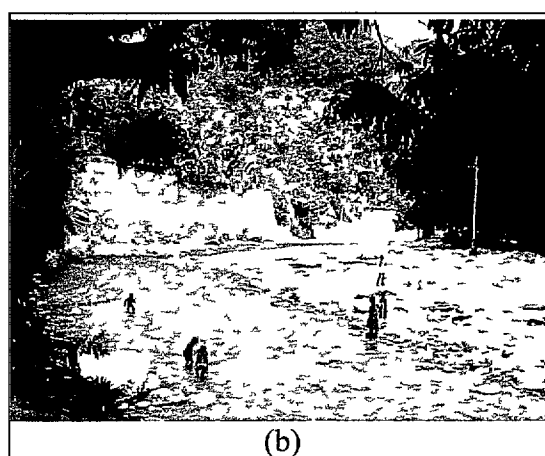
**Photo 17** Severe bank erosion which destroyed the road and canal Left from downstream side Right from upstream side A drastic river course change is required to prevent further bank erosion

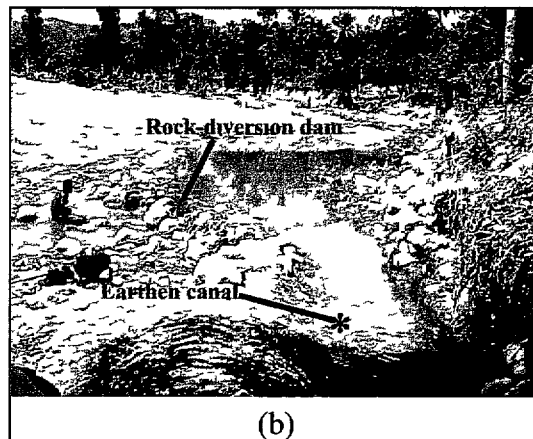
**d The irrigators in the westside secondary canal have started to damage/abuse the conveyance systems to get water into the canal** - This damage to the irrigation system is an indirect effect of the hurricane The west-side secondary canal (*photo 18a*) had water flow at the time of observation The water was carried from the river using a rock diversion dam (*photo 18b*) and an earthen canal which the irrigators installed The water was conveyed to the secondary canal by the earthen canal (*photo 19*) Also a portion of the water was conveyed to a nearby field by passing the water through a dug-out hole under the secondary canal We did not observe any other cases, but if the situation (no water supply in the main canal) continues, there will be more of this and similar types of damage/abuse and eventually irreversible damage will be done to the irrigation system One observation showed that canal maintenance was not adequately done, due to lack of flow or lack of a maintenance program This was shown by the accumulated trash and sediments in most of the canal sections

**Photo 18** West side secondary irrigation canal which carries water where the main canal is dry. The water was diverted by a rock-diversion dam and an earthen canal built by the irrigators of the west side secondary canal.

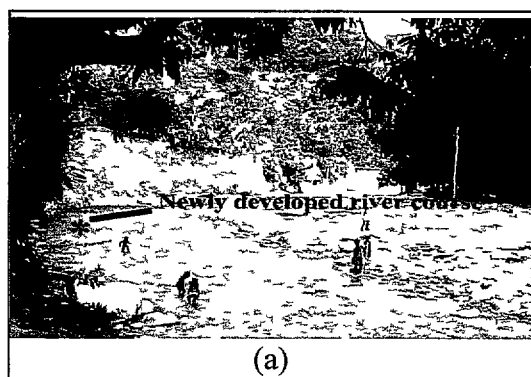
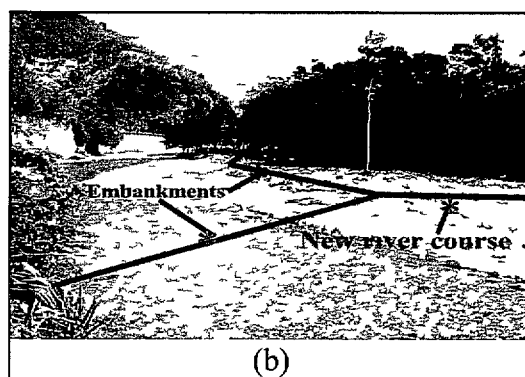
**e Diversion of the perennial river** - The newly eroded east bank near the intake structure (*photo 20*) not only caused problems to the irrigation system but caused loss of community infrastructure Without action to protect the bank, it will continue erode into further inland One potential solution in addition to protecting the river bank with conservation structures is to divert the current course of the flow *The area between the damaged intake and the present river course (photo 20b) needs to be excavated to open a new course away from the eroded bank. The excavated material may be used to block the current flow to guide the river into the new course The eroded river bank should be re-graded with an acceptable slope and protected with rock-concrete structure or gabions*

**Photo 20** (a) The flooding caused bank erosion and changes the river course further inland while depositing more sediments on the right side of the flow. Stabilization of the bank and change of the river course is necessary to protect the hillside. (b) shows approximate location of embankments and new river course open.

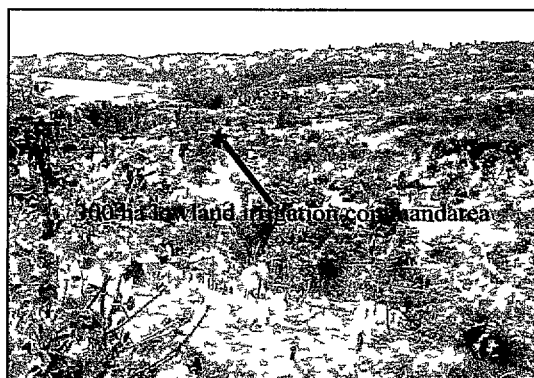
**Photo 22** The 300 ha major irrigation command area, the lowland on the west bank of the Jacmel River

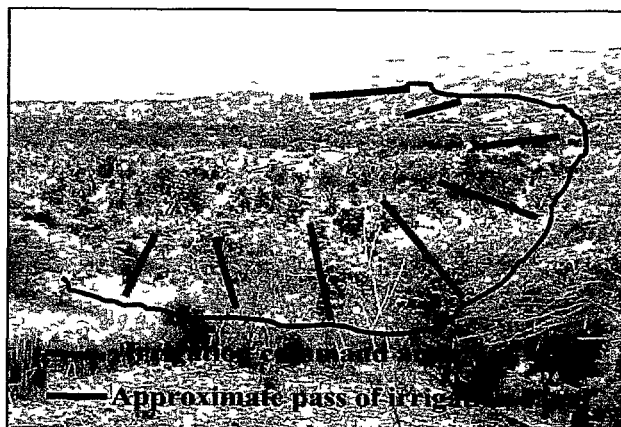
**Photo 23** Approximate pass of the proposed irrigation canal along the hillside

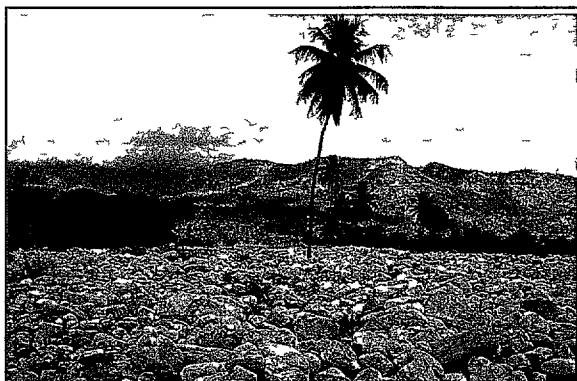
Between the irrigated plain of Peredo and the intake at Rodaille, the primary irrigation canal crosses a major dry streambed (*photo 26a*) which drains into the Plantils. This is an intermittent stream shown on the map to originate 7.5 km to the northeast, west of the village of Berry. Another fork of this intermittent stream originates approximately 5 km due north of its junction with the Plantils. It is probably safe to estimate that the above-mentioned streams drain approximately 12 - 15 km length of the mountain range which runs east to west.

**Photo 26a** Large, dry riverbed of intermittent stream that joins Plantil river below intake at Roadaille. Note partially vegetated foothills in background, with evidence of cultivation.

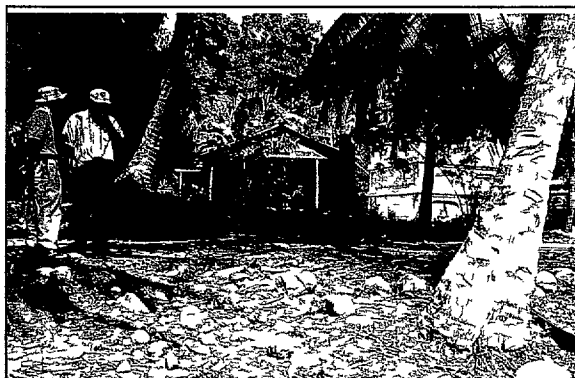
**Photo 28** Dwelling and tomb across from damaged canal intake at Rodaille. Brown stains on the lower section of tomb show watermarks indicating level of floodwaters from Hurricane Georges a few meters above normal level of stream. Dr. Yoo and Marc-Eddy Martin shown at left of photo.

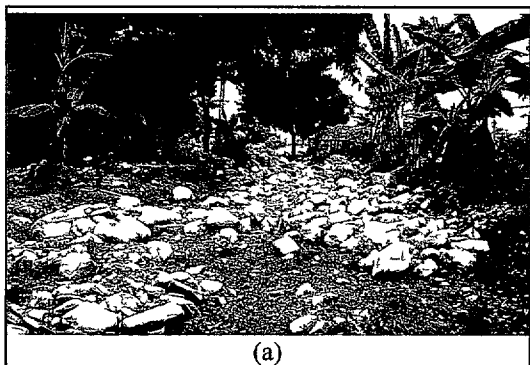
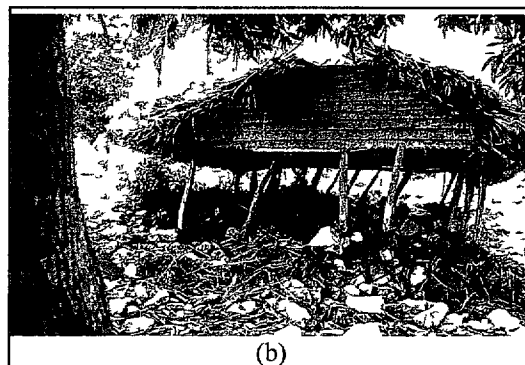
**Photo 29** Boulders deposited by Hurricane Georges by overflow from intermittent stream shown in a) farmland b) destroyed farm structure

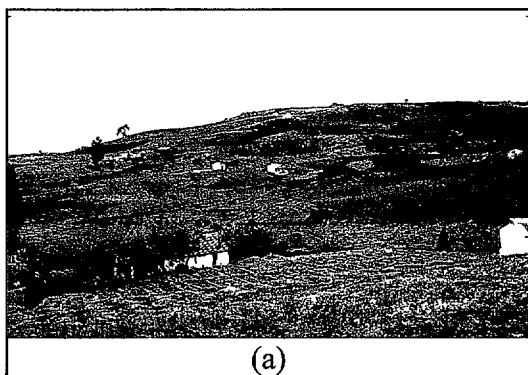
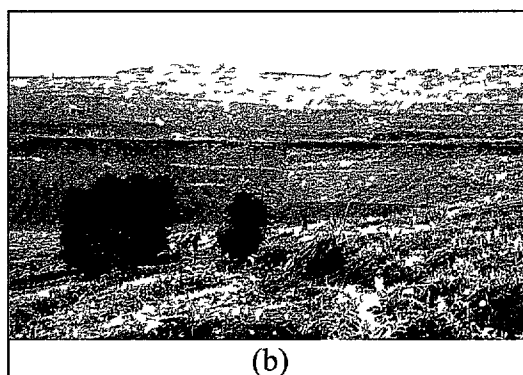
**Photo 31** a) Farming at Platon L'Etang, near Seguin, without use of soil conservation practices Few trees and little natural vegetation remains b) Steep hillside in background shows eroded surfaces and poor land husbandry

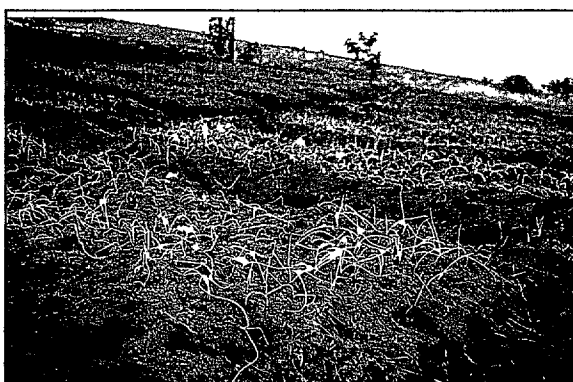
**Photo 32** The vegetable production typical of this region does not provide adequate cover of the soil Recently transplanted onions on raised beds shown here are typical of the agriculture in this area Cabbage, carrot and Irish potato are other important crops

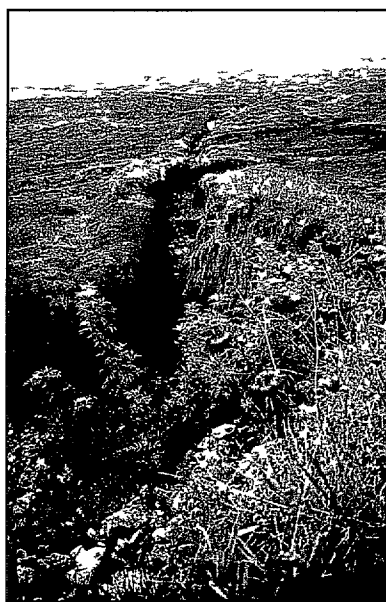
**Photo 33** Gullies on moderate slopes near Cassedent Note sparse vegetation Unless corrective measures are taken gullies like these will spread at an alarming rate
